Transformer replacement in Sentmenat, Barcelona

Project:	Transformer replacement in Sentmenat, Barcelona
Project location:	Sentmenat electrical substation, Barcelona , Spain
Equipment:	12 axle lines of SPMT , 8 climbing jacks with 90t unit capacity
Weights:	Transformer withdrawn: 205t and transformer installed: 230t
Key Features:	Reduced Costs; Bespoke solution; Minimised disruption

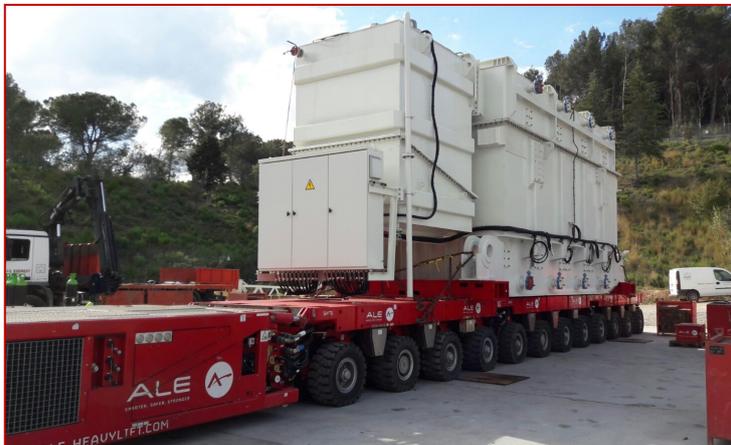
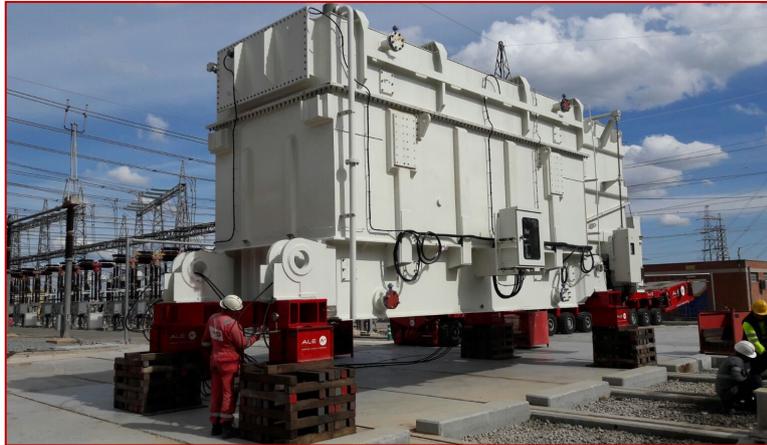
ALE has carried out the replacement of a 205t transformer, located in the work area, with a second 230t transformer, located in the repair area, within the Sentmenat electrical substation.

The first stage involved transporting the transformer from the work area. The transformer was skidded outside of the work area by pulling with cable winches and jacking it up with 8 climbing jacks until it was rested on the SPMTs. The transformer was transported using 12 axle lines of SPMT to a temporary auxiliary area.

The second stage involved the installation of the replacement transformer. The second transformer was skidded from the repair area by direct pulling with cable winches. Once it was outside of the repair area, the transformer was jacked-up using 8 climbing jacks and transported using 12 axle lines of SPMT to the work area, where it was lowered and supported on its bogies to finally slide into its final position.

The final stage consisted of transporting the first 205t transformer from the temporary auxiliary zone to the repair area using 12 axle lines of SPMT. It was jacked and skidded into position using the techniques above.
