Replacement of an engine on a cargo ship in Ferrol, Spain

Project:	Skidding and jacking for the replacement of a cargo ship engine
Location:	Ferrol, A Coruña, Spain
Equipment:	25t capacity skidding system; 60t capacity climbing jacks; jumping beams
Weights:	Engine - 67t, alternator - 38t
Key Features:	Minimised disruption; short notice mobilisation; bespoke solution

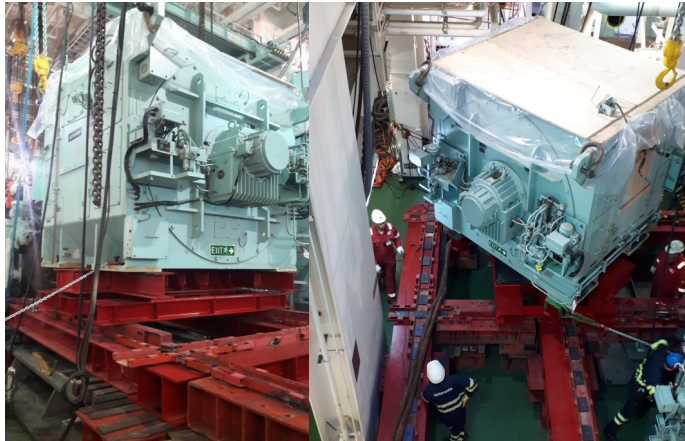
Alternator being skidded along the top of a turning table

- The alternator, weighing 36t, was removed by skidding it along the top of a turning table, supported on 25t capacity skid beams, to a temporary landing area inside the engine room.
- To obtain additional space for the removal of the engine, the engine block was skidded transversally.
- The motor was raised using chains that had been installed in the upper cover. This enabled 2 turning tables to be installed, which were used to rotate the engine by 90°.
- The motor was skidded transversally to align it with the skid tracks coming off the vessel.
- As the ship was afloat, ALE needed to account for the effect of the tidal variations when moving the engine from the ship to the dock. Jumping beams were supported on hydraulic jacks, which enabled a constant level to be maintained for the installation of skid tracks. The old engine could then be smoothly skidded onto the dock.

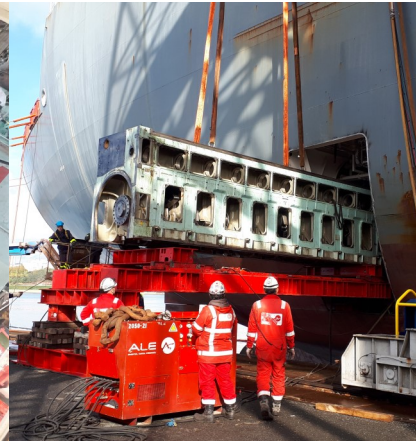
Motor exchange

The installation of the new engine was completed following this sequence in reverse.
